Damage/Needs Assessment

In the Affected Area of
The 2011 off the Pacific Coast of Tohoku
Earthquake and Tsunami

11th of April 2011

SEEDS Asia, OYO International Corporation and Kyoto University

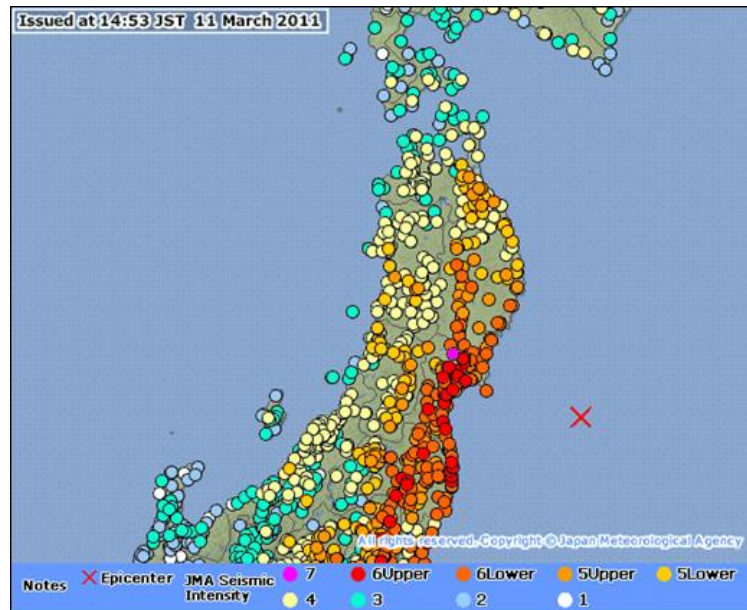
Figure 1. Seismic intensity map for The 2011 off the Pacific coast of Tohoku Earthquake (JMA, 2011)

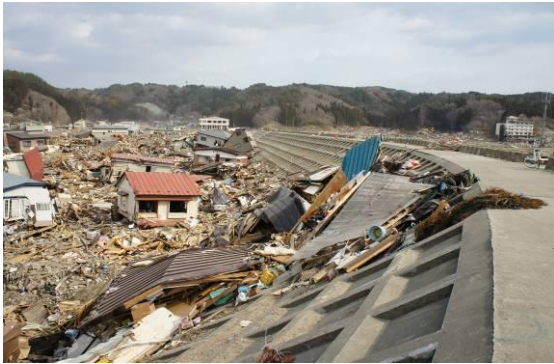
Taro area was damaged by the tsunami caused by Syowa-Sanriku Earthquake, which occurred in 1933. After the event, 10-meter dikes are built to prevent damages by future tsunami. But the area had devastating damages by the tsunami this time. Figure 3 shows the dike and damages. Figure 4 shows the buildings which survived from the tsunami because of the dikes. Most of the houses and buildings are flooded and collapsed by the tsunami. But some buildings are remained. From this result, it was identified that the dikes could not prevent tsunami damages but that they are effective to some extent.

Figure 3. Damages by the tsunami in Taro area

Infrastructure measures: Due to past several events in the same area, infrastructures like sea-dykes were built in several places. The 10 m high, 2.5 km long dyke in Taro, Miyako town in Iwate prefecture is a classic example of this. Although part of the dyke was damaged, and tsunami overflowed the 10 m dyke, it surely reduced the impacts of the event. In Kamaishi, in Iwate prefecture, tsunami evacuation building was built with instructions, and people were safe who evacuated above 4th floor.

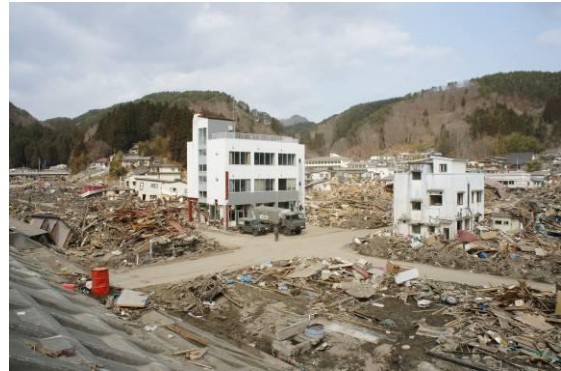
Figure 4. Buildings which survived during the tsunami in Taro area

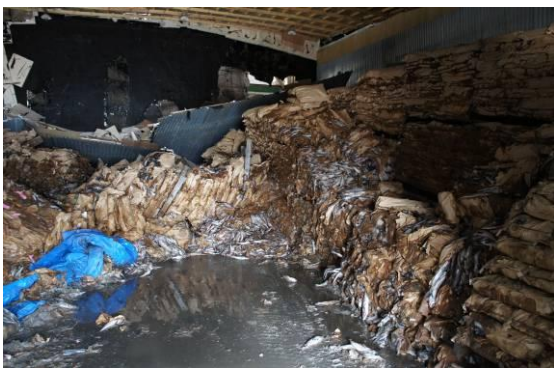
Figure 5 and 6 show fishes which had been kept in storage. These fishes planned to be carried to other places but these were damaged because of the tsunami. Therefore, the fishes will be disposed. The survey team visited the Miyako Fishery Association to understand damages and needs on fisheries. The main works of member of the association are fishing and aquaculture. Because of the tsunami, many members lost their own fish boat. In addition, it is impossible to do aquaculture because the members lost equipments for it and many kinds of things including rubble, car, waste, and others were flooded to sea. Therefore, the members can not start their work. Other problem is insurance. All members did not purchase insurance for their own properties. If such member starts their works, they have to purchase equipments or ships by themselves. In addition, most of fisheries are elderly. According to the interview, the average age of the fisheries is around 60 years old. It was expected that it is seriously difficult to recover fishery industry in Miyako without any external help.

Figure 5. Damages to frozen fish in Miyako area

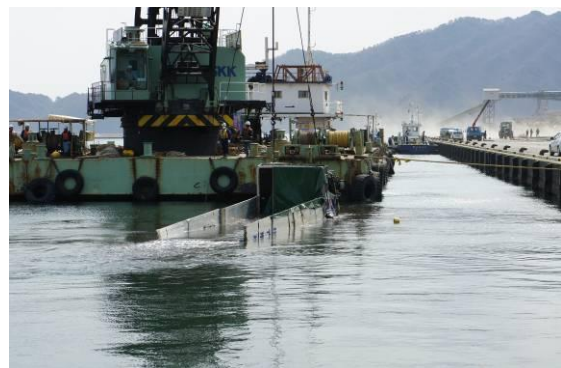
Figure 6. Destroyed truck is lifted from sea in Miyako

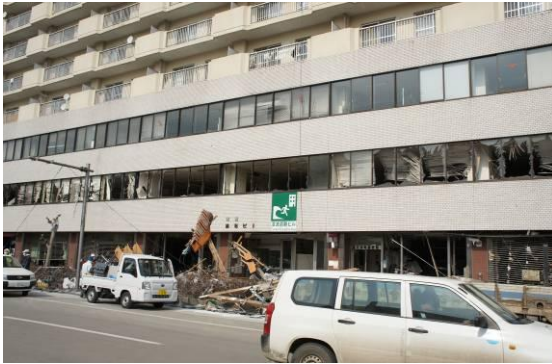
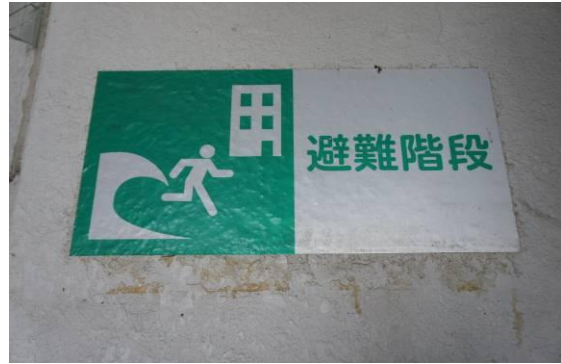
In Kamaishi, there are two tsunami evacuation building officially decided by the local government for evacuation. The survey team visited one of them shown in Figure 7. The number of stories of this building is eight. The first to third floors are used for offices and fourth to eighth floors are residential spaces. There are also road near this building for evacuation in tsunami situation. One of inhabitant told the tsunami came to the third floor of this building. Local residents were evacuated in this building and the road temporarily. In addition, he mentioned they had evacuation training 3rd March. It is expected that the training was effective for local people to re-realize the place for evacuation and how to do in tsunami situation.

Figure 7. Evacuation building [8 storey building with evacuation more than 4th floor]

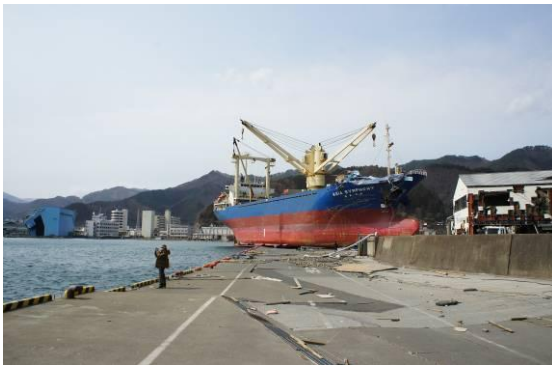
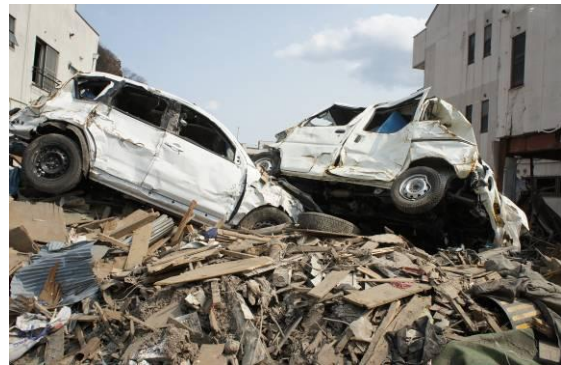
Figure 8. Damages by the tsunami [left: transported ship, and right: destroyed cars]

In addition, he explained the situation after the tsunami. Kamaishi city was severely damaged (refer to Figure 8). Because of the tsunami, communication system like mobile phone and internet were out of order for a week. Therefore, local government could not transfer information to outside area, and other local government or people outside could not know the situation of Kamaishi city. Japan Self-Defense Forces reached to the city one week after.

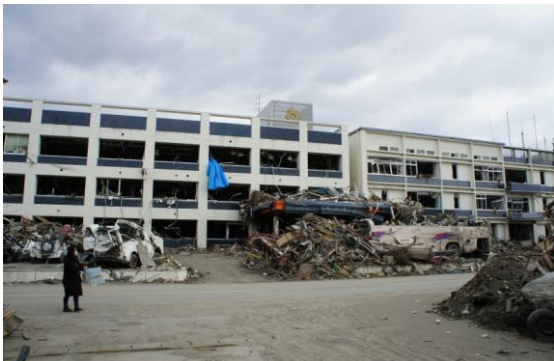
This city was devastated. Figure 11 is the government office building and Figure 12 is the surrounding area of the building. The government office building is damaged and it is possible for the government to work there. It is expected that all of documents, facilities, and equipments were severely damaged. Around the government building, most of houses and building were flowed. It is difficult for local people even to find their own property or belongings.

Figure 11. Damaged local government building

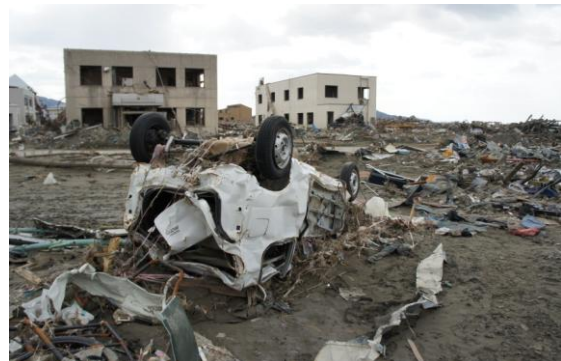
Figure 12. Damages by the tsunami

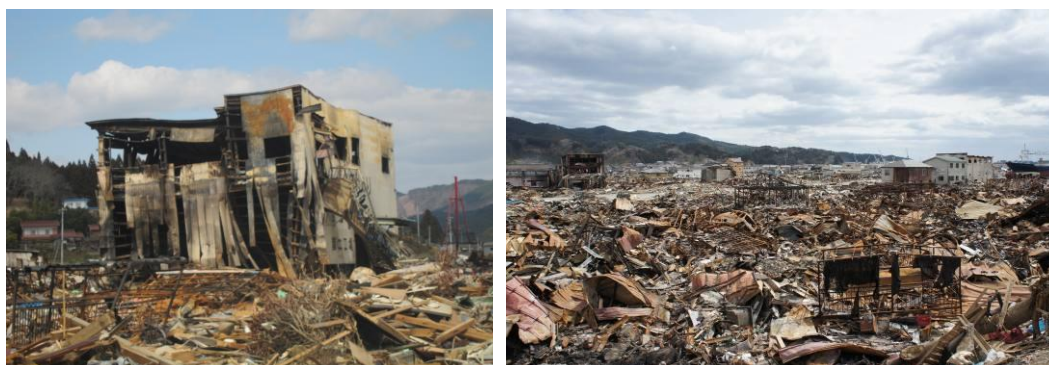
Kesennuma city is severely damaged. In this city, heavy oil was flow out and it was burned. Therefore, many burnt pieces of rubble are seen in the city (refer to Figure 15). The city was devastated. Train could not run in this area because rail tracks are also damaged (refer to Figure 15).

Figure 15. Damages by tsunami and burnt areas

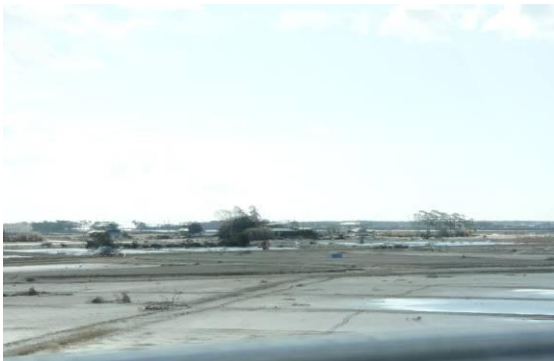
Yamamoto town was heavily damaged by the tsunami because it is located in plane area (refer to Figure 16). But the government building was remained. In the first floor of the building, FM station was established. The roles of the FM station were similar to that of Ofunato city. The person who is in charge of management of FM station is a person who retired from TBC (Tohoku Broadcasting Company). He moved to live in this town after his retiring. Because he was an announcer in TBC and had several connection due to his working history, he and local community could establish FM station. He has similar aims on FM station which the person in Ofunato city has. The FM station invites government persons including the town mayor and asks them to announce the current status and future plan for recovery and reconstruction (refer to Figure 17). As mentioned before, the person who is in charge of the FM station emphasized the radio should be utilized for community development as well as prompt and appropriate recovery and reconstruction. Inviting the government persons is one of challenges to achieve it. Because of this challenge, FM station can make the linkage between local community and the government. He is considering that FM station would be able to be continued for community development if the local government understands the importance of FM station.

Figure 16. Damages by the tsunami

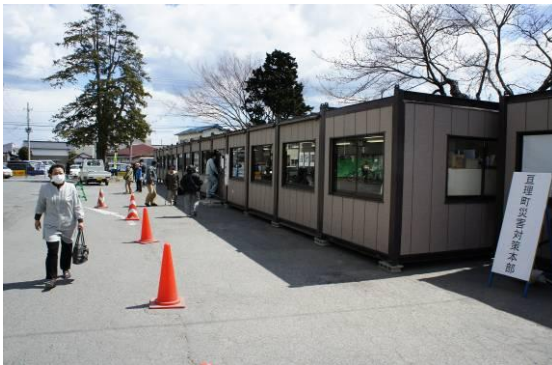
Figure 18. Temporary government office

Watari town is the next town to Yamamoto town and these towns are located in the same county named as Watari-gun. The government building of Yamamoto town was being used even after the disaster but the building of Watari town was not. But temporary offices were provided from outside. In the temporary offices, the government could continue recovery works and others. Next to the office, FM station was established (refer to Figure 18 and 19). The person who is in charge here had the connection with the person at FM station in Yamamoto town. Therefore, Watari town

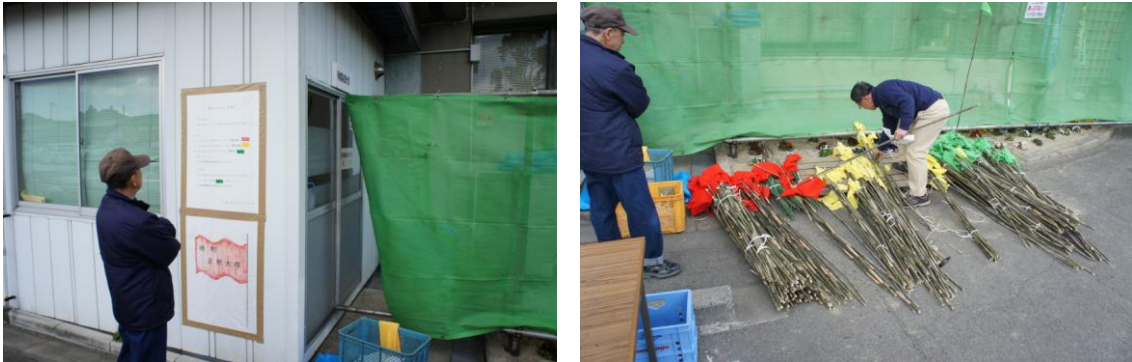
Figure 20. Three kinds of flags to show the house status

One of the big problems in tsunami affected area is how house rubbles is demolish earlier to start recovery and reconstruction works. Under the general government works, house owner asks the government to demolish. But the government has more works in emergency situation, compared to general time. In Watari town and other city/town, house owner can leave message on demolition, using the flags (refer to Figure 20). House owner select one of color flag from three flags and give it to their own house. Red means houses and rubbles round house can be demolished by the government or appointed companies. Yellow means only rubbles around houses can be demolished and green shows any demolition is not necessary. Because of this, it is easy to understand house owner's decision and the government can start recovery works earlier.

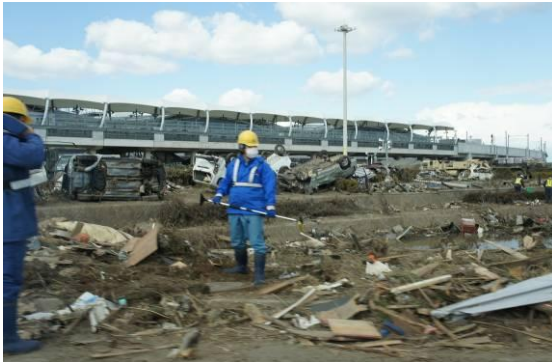
Sendai airport is located in Natori city. The airport is the biggest one in Tohoku area and it is not available because of the disaster (refer to Figure 23). Therefore, relief goods or other necessary things needs to be carried from other airport of Tohoku area or on the road. In the residential area of Natori city, there is the small hill (refer to Figure 24).

Figure 23. Damages around the airport

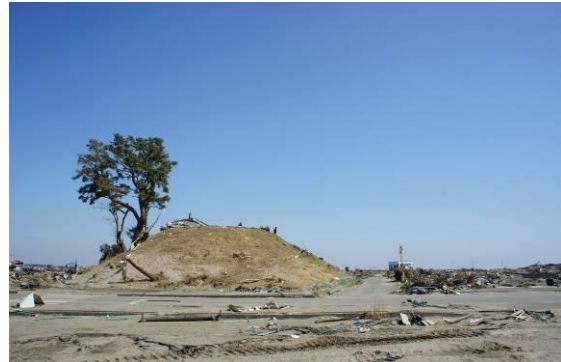
This place is a temporary evacuation place for Tsunami but this hill was also attacked by the tsunami. Figure 25 is the memorial thing for the tsunami this time. Some survived people visit this hill to pray. Figure 26 is the memorial stone for the tsunami caused by Syowa Sanriku Earthquake in 1933. The history of that tsunami was mentioned on the stone. The stone was established on the hill but flowed by the tsunami. It was considered that local community people visited the hill and know the past tsunami there before the tsunami and their awareness had been raised. But, the tsunami this time was much larger scale than the past one.

Figure 24. Hill for tsunami evacuation in residential area

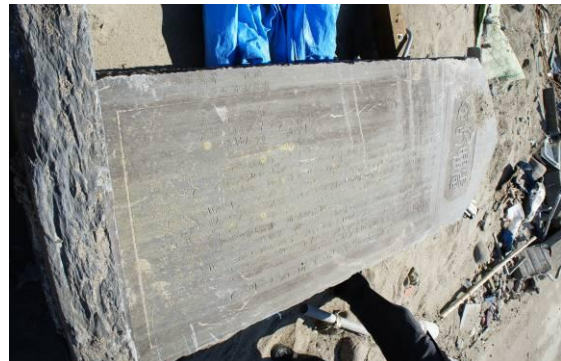
Figure 26. Memorial stone flowed from the hill

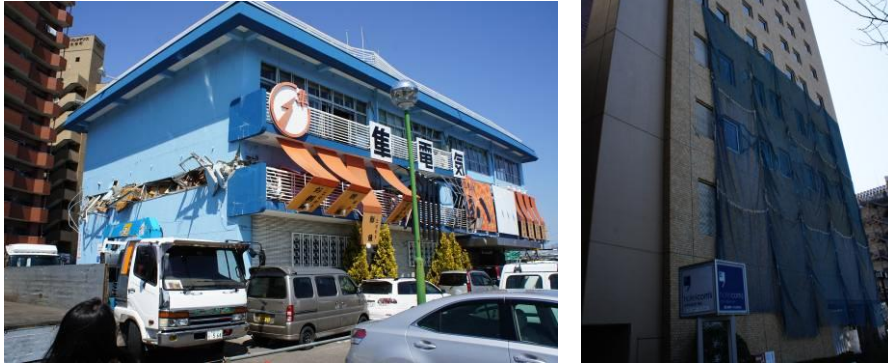
Iwate and Miyagi Prefecture are the most affected prefectures by the Tsunami. This time, the scale of the earthquake was also historically much bigger one. But collapsed houses or buildings by earthquake are not seen in Iwate Prefecture. In Sendai city and other city/town in Miyagi Prefecture, some damages by the earthquake are seen. For house, clay tile on a roof were damaged. Some large scale building in Sendai city had damages on the structure (refer to Figure 27). However, completely destroyed houses

Figure 27. Building damaged by the earthquake
